Apartment Building in Brogården, Alingsås SE

IEA SHC Task 37

Advanced Housing Renovation with Solar & Conservation

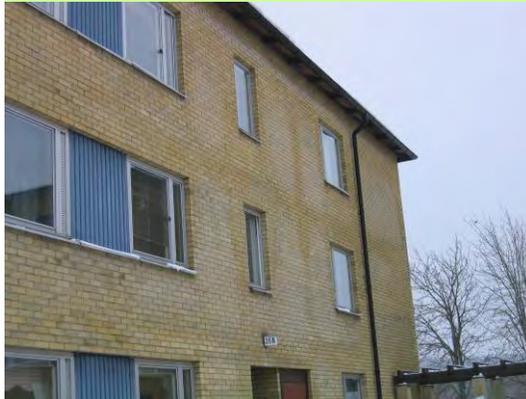
Existing facade with thermal bridges

Balconies moved to hang outside facades to decrease thermal bridges

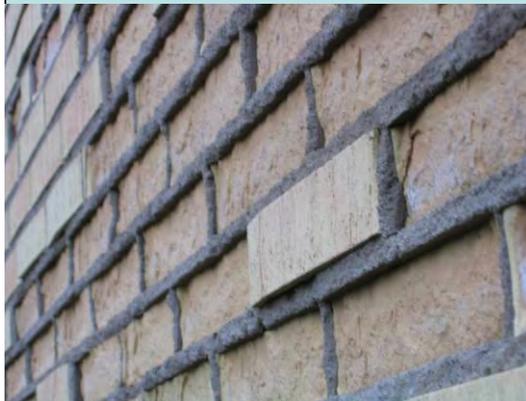
Worn out facade material

- Added insulation (ground floor, exterior walls and roof)
- New facade material
- New windows
- Increased air-tightness of the building envelope
- New balconies relocated to outside the facade
- New build entrance vestibules
- New ventilation system with heat exchanger
- New energy-efficient household appliances
- Solar collectors for domestic hot water
