Apartment building in Albertslund, DK

PROJECT SUMMARY

IEA – SHC Task 37

Advanced Housing Renovation with Solar & Conservation

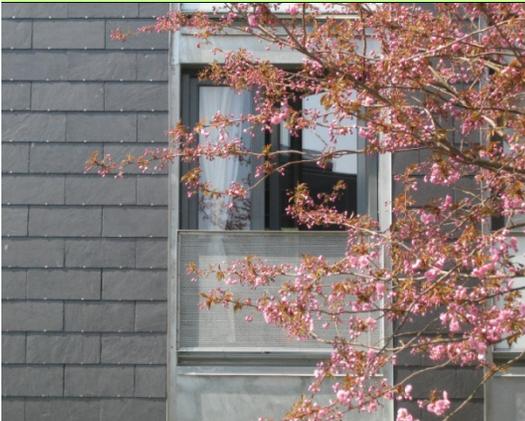
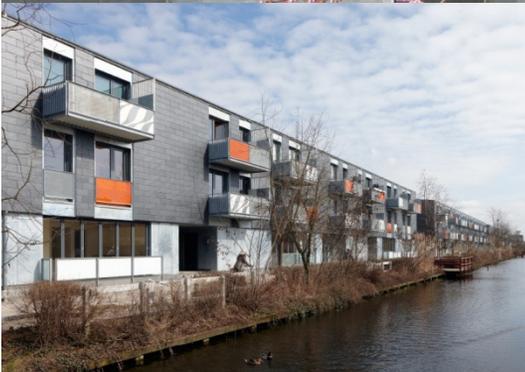
Spanish nature slate is used in the renovation in order to respect the original architecture.
